Task Order 2 Enhanced Preliminary Assessment

KAPALAMA MILITARY RESERVATION
HONOLULU, HAWAII

February 1990

ENHANCED PRELIMINARY ASSESSMENT REPORT

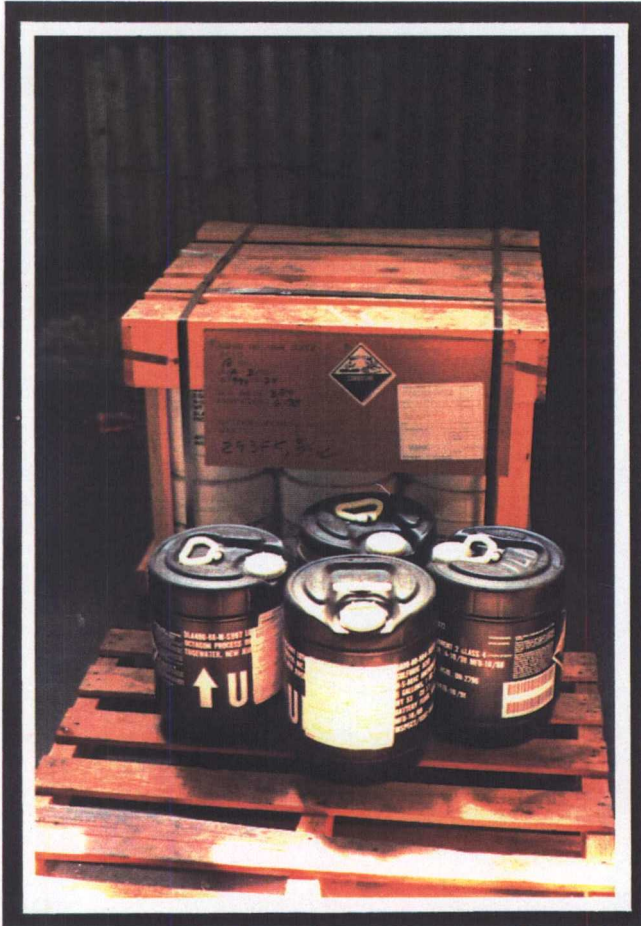
11. Battery Acid

- Battery acid (concentrated sulfuric) in 5-gal containers.
- Caustic cleaning compound (sodium hydroxide) of various sizes.
- Aromatic organic solvents such as toluene and xylene in 5 to 55-gal quantities.
- Low flash point solvents such as acetone and methyl ethyl ketone.
- Lindane (organochlorine pesticide).
- Paints, both aqueous and oil based, possibly containing lead and/or cadmium.

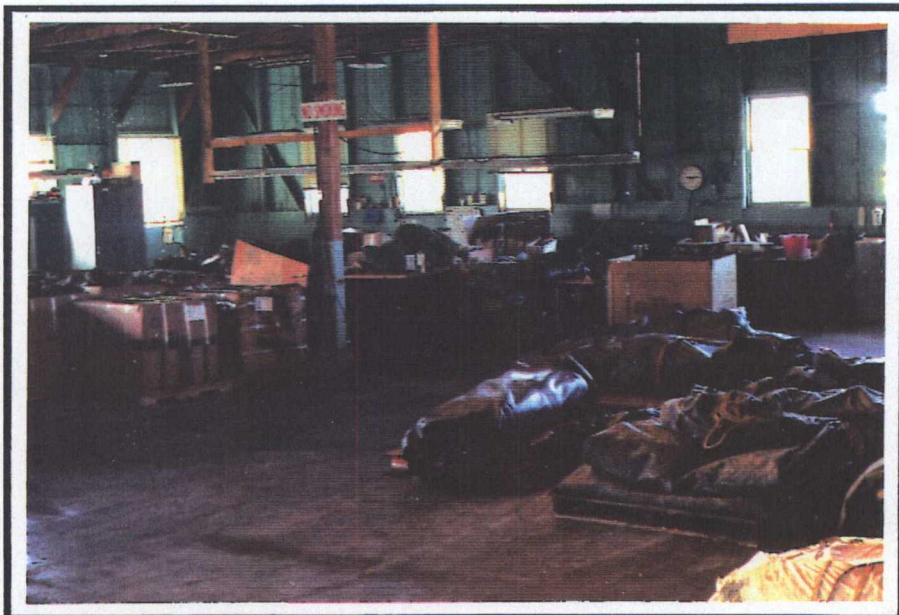
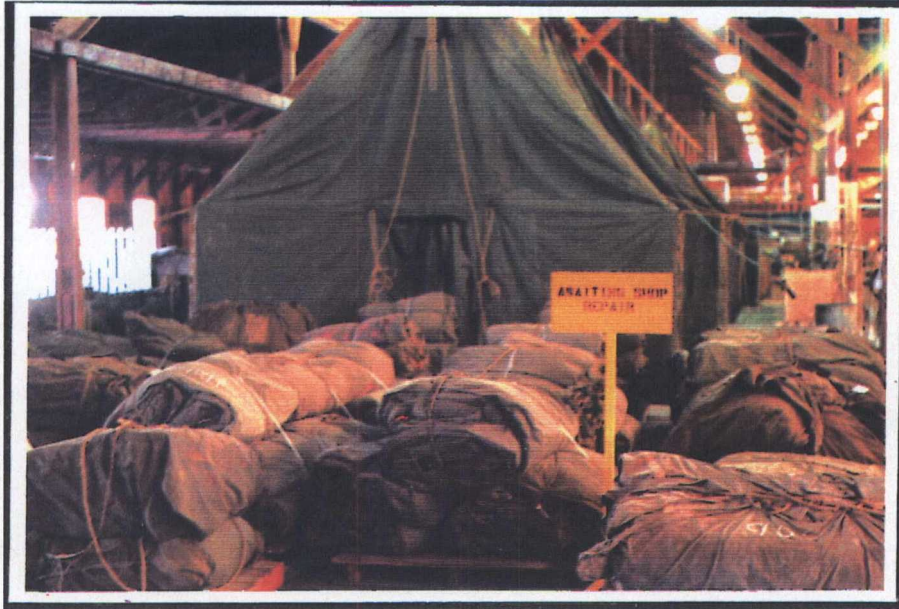
CANVAS REPAIR AREA, BUILDING 924

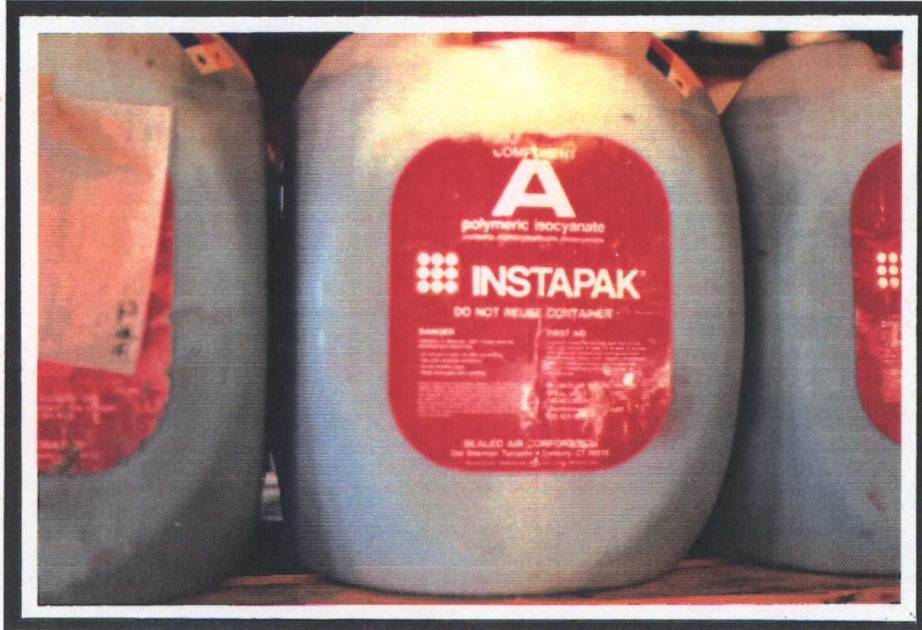
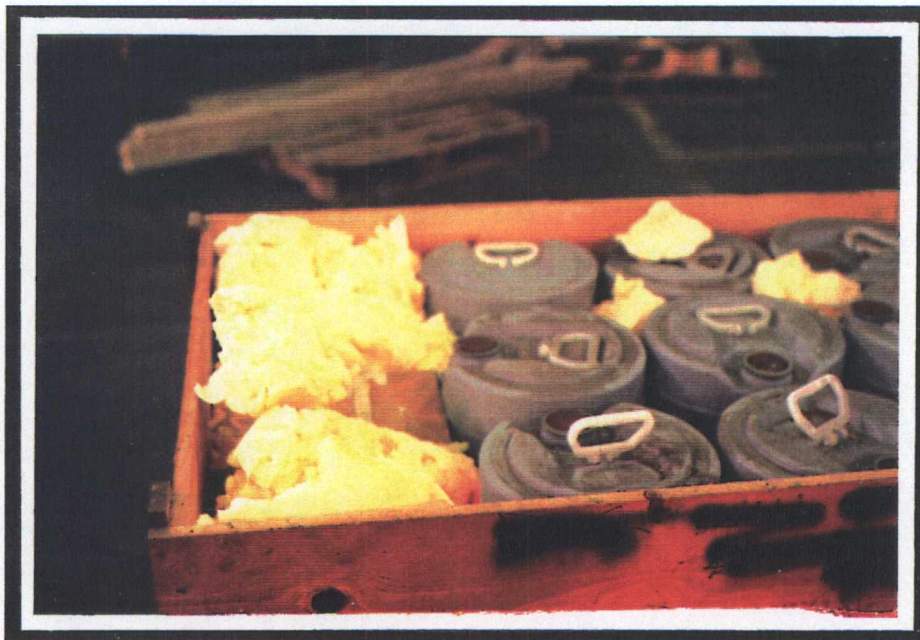
FOAM PACKAGING AREA, BUILDING 924

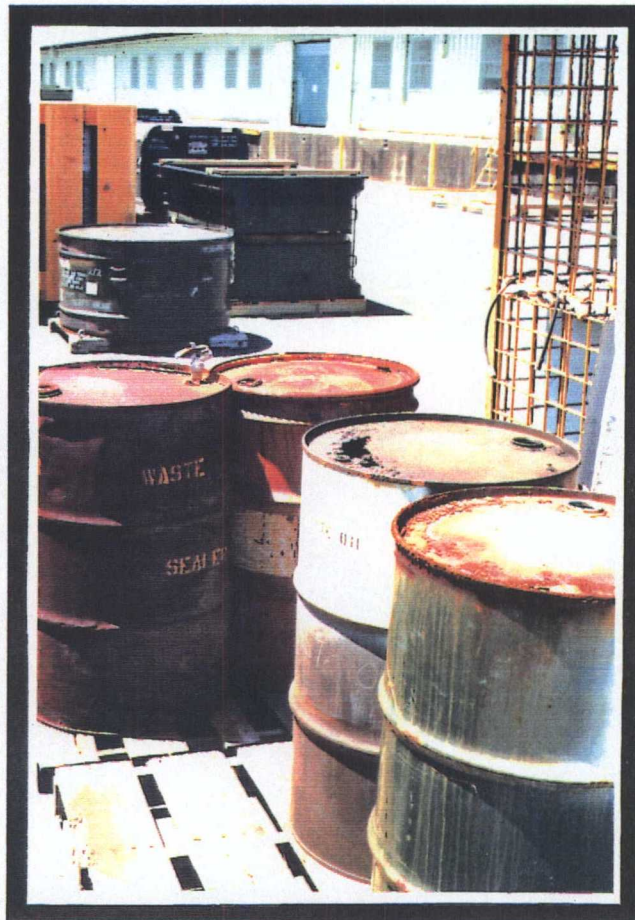
29. RUSTED DRUMS OUTSIDE BUILDING 924

There are a few old rusted drums on pallets just outside Building 924. The pallets are located on asphalt, and the only drains in the area are connected to the storm sewer. These are labelled as containing "waste oil" and are now empty, except for 1 to 2 in. of what appears to be rainwater in two of the open drums (photo 29).

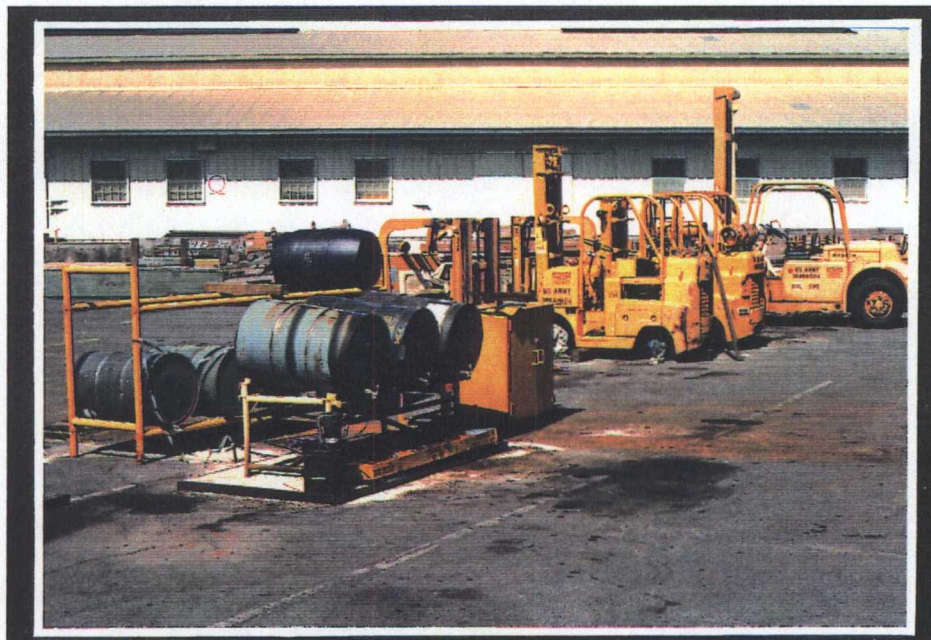
30. FORK LIFT MAINTENANCE AREA, BUILDING 925

- Building 925 - Maintenance & Repair of Forklifts - oils, greases, solvents, and hydraulic fluids used in the repair and maintenance of forklifts in an area adjacent to the building.

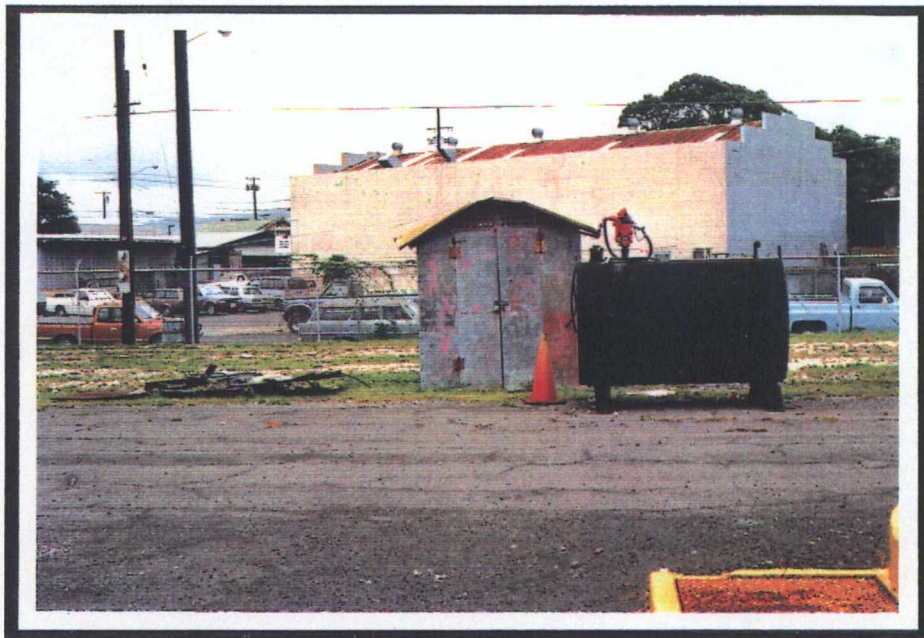
40. KEROSENE STORAGE TANK

- approximately 300-gal kerosene tank adjacent to a grassy area.
 - 5,000-gal propane tank adjacent to Building 925.
 - 500-gal propane tank adjacent to Building 921 reported by personnel but not observed during site visit; 150-gal propane tank adjacent to Building 922.

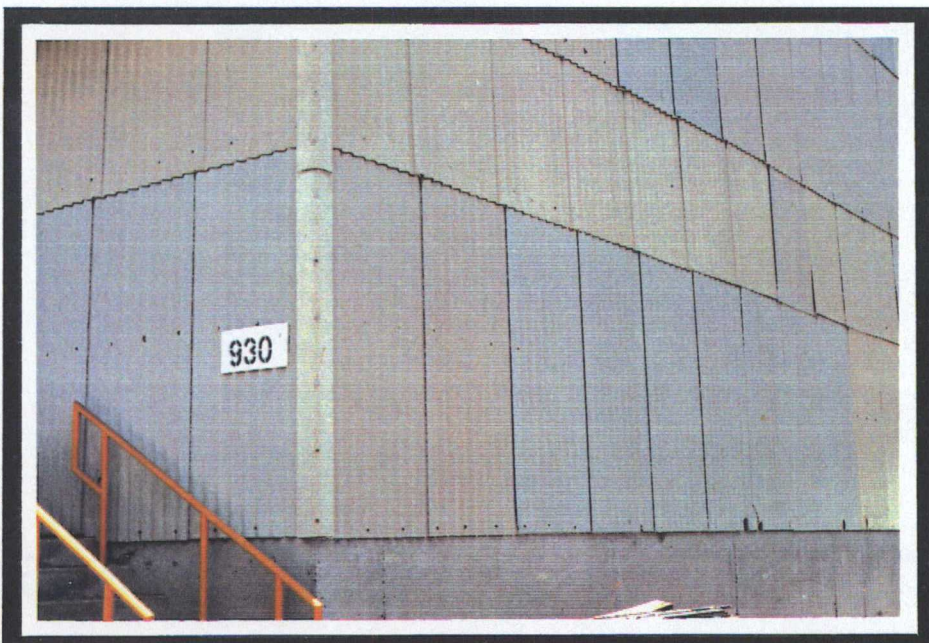
42. GENERAL CONDITION OF TRANSITE SIDING

- Asbestos - numerous onsite buildings constructed with Transite siding and other asbestos-containing material. Some siding material is broken along the lower side of buildings.

Wipe, destructive, and dust sampling of building interiors is recommended for most of the primary ESOs discussed in Section 3. The presence of asbestos materials in certain buildings in the Phase II area has been confirmed by previous sampling; therefore, sampling for asbestos is recommended only for Phase III buildings.

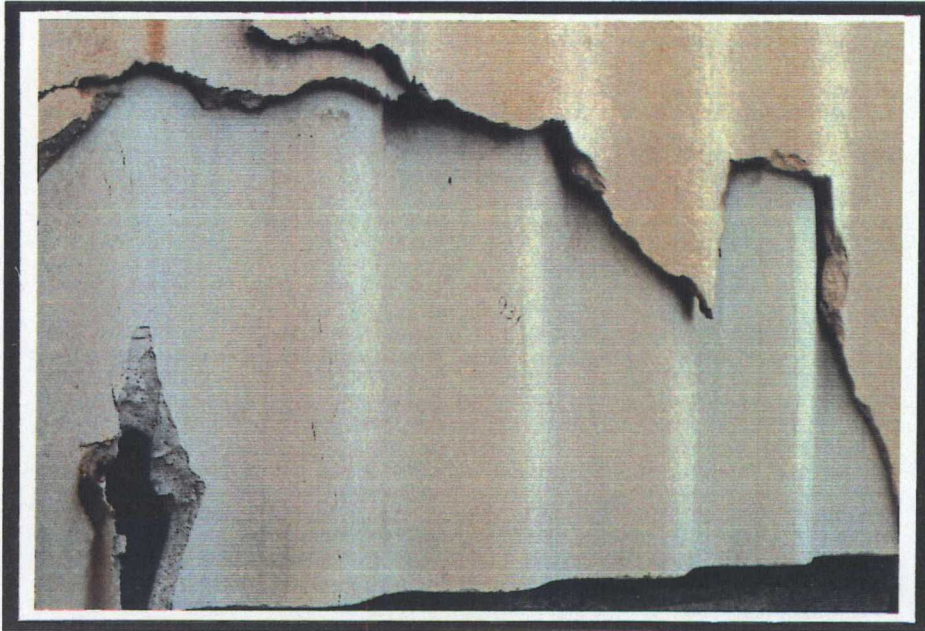
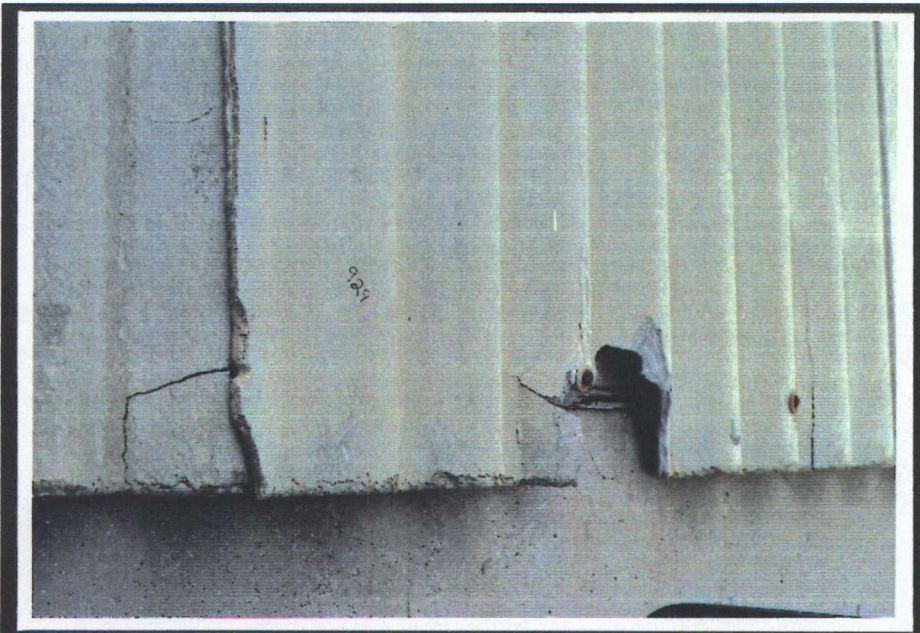
GENERAL CONDITION OF TRANSITE SIDING

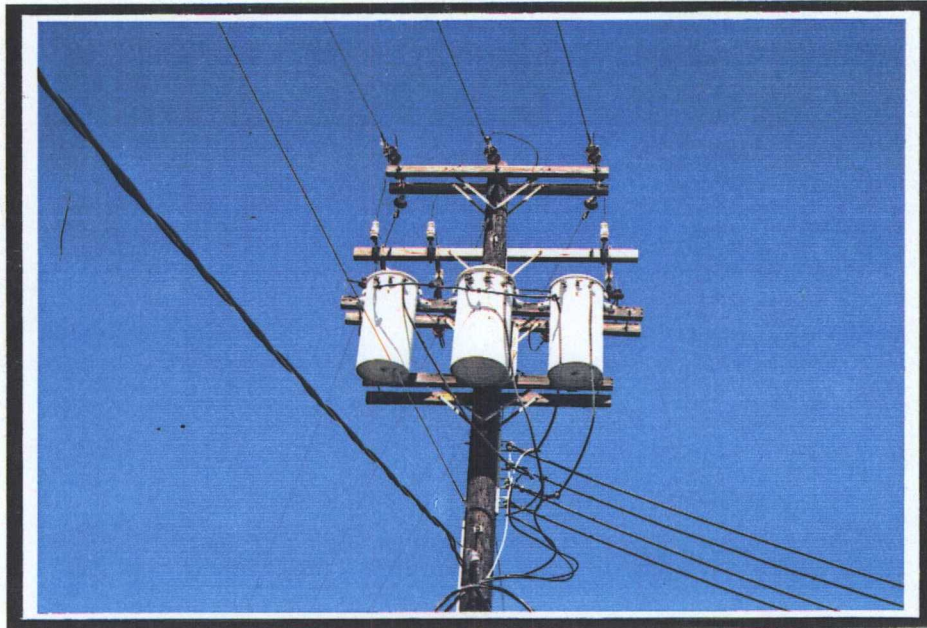
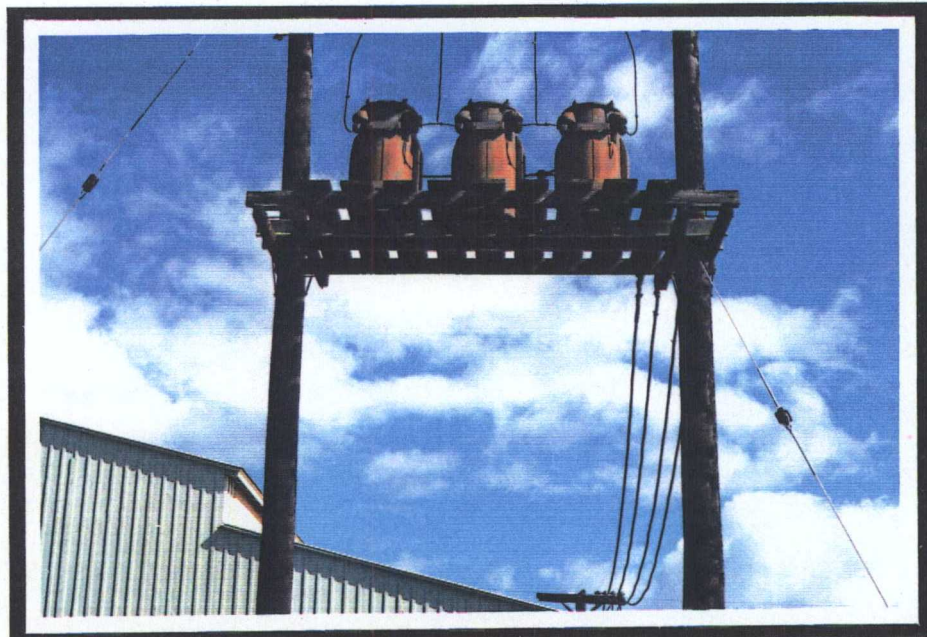
- Transformers - approximately 40 transformers, two pad mounted, the remainder pole mounted. Fluids have not been tested for polychlorinated biphenyls (PCBs) content. Two apparent minor leaks observed.

TRANSFORMERS

All transformers on the property potentially contain PCBs and two of them appear to have leaked in the past. An inventory should be made of all transformers remaining on the property (except Phase I), and each transformer should be sampled for PCBs.

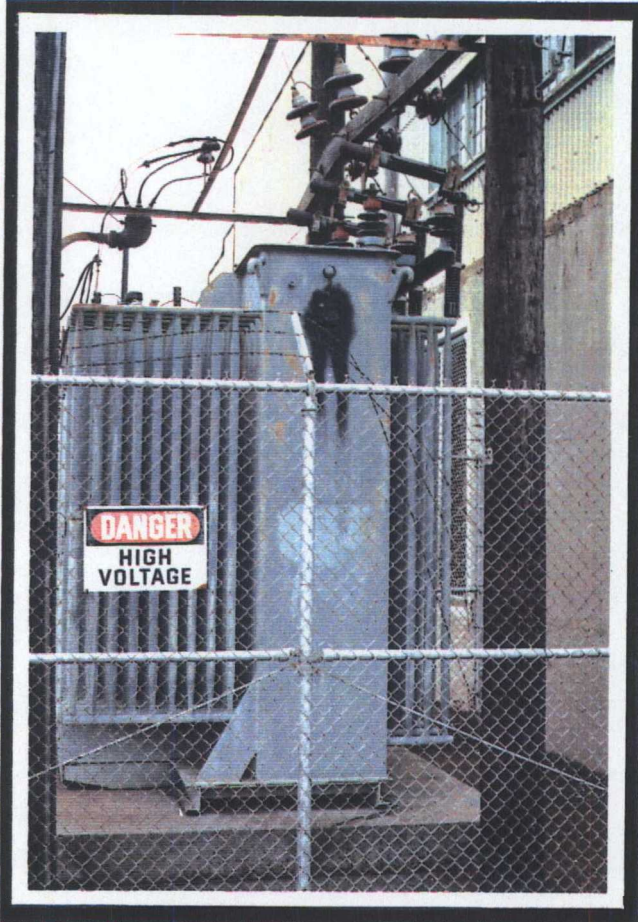
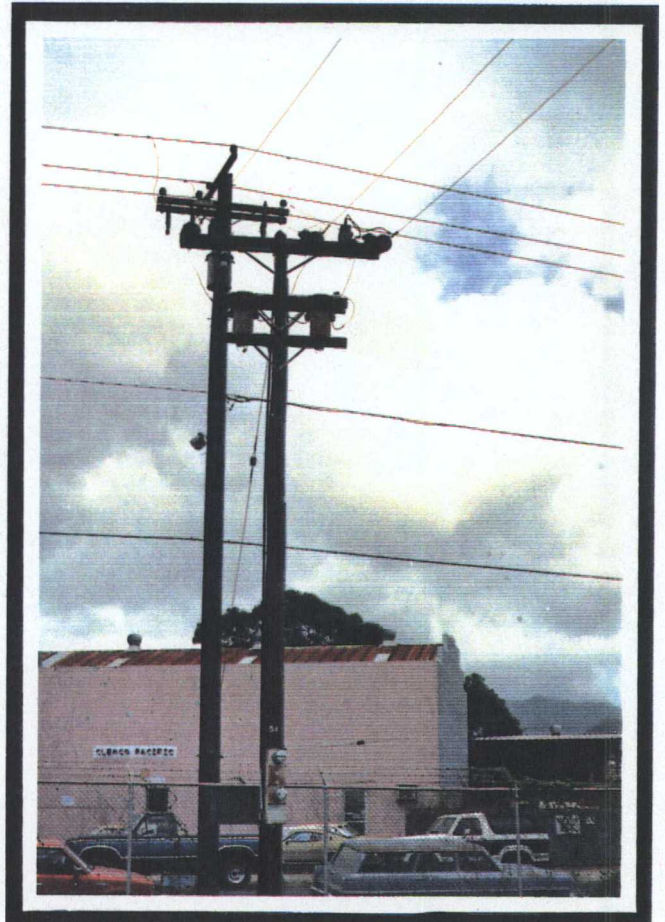
TRANSFORMERS
